TEST REPORT

AAMA 501.5

REPORT NO.: 1517.02-106-11-R0

SERIES / MODEL: Tru-Brix Rainscreen System

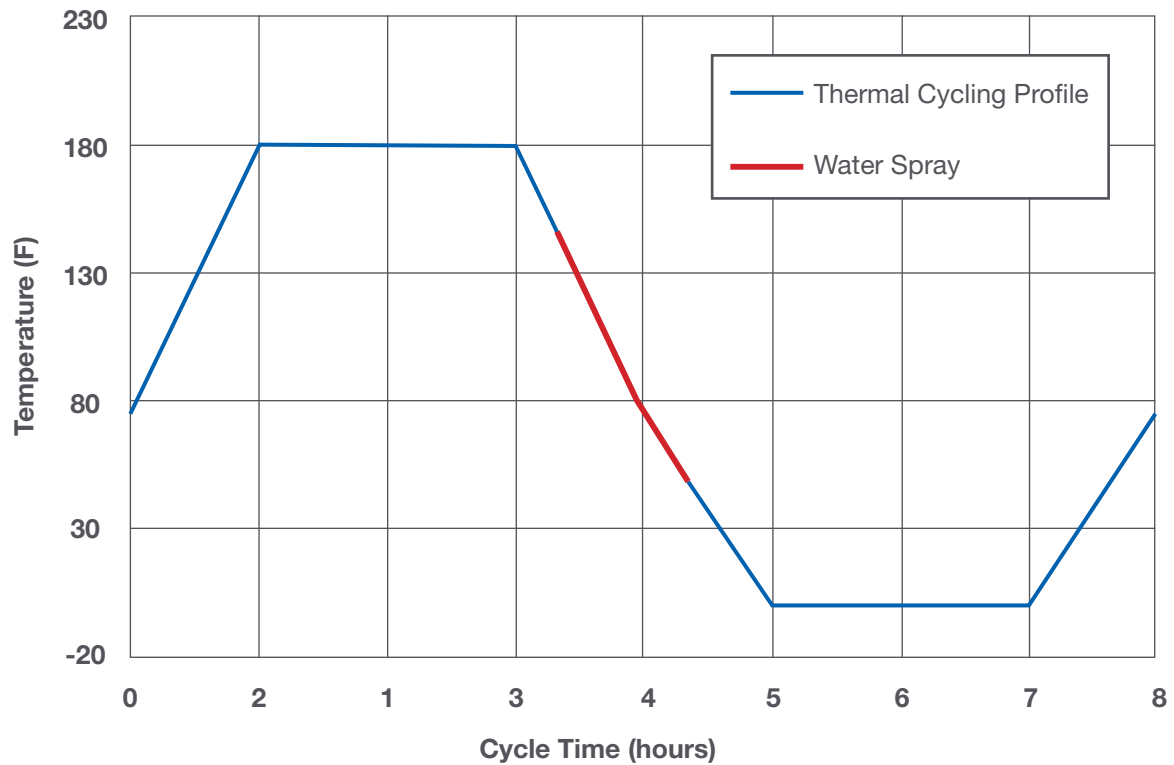
Thermal Cycling Profile

Three thermal cycles were performed from 0°F to 180°F with 1 hour of water spray at 75°F, (Reference Chart in Appendix A for details.)

Ten thermal cycles were performed from 0°F to 180°F with 1 hour of water spray at 75°F (Reference Chart in Appendix A for details.)

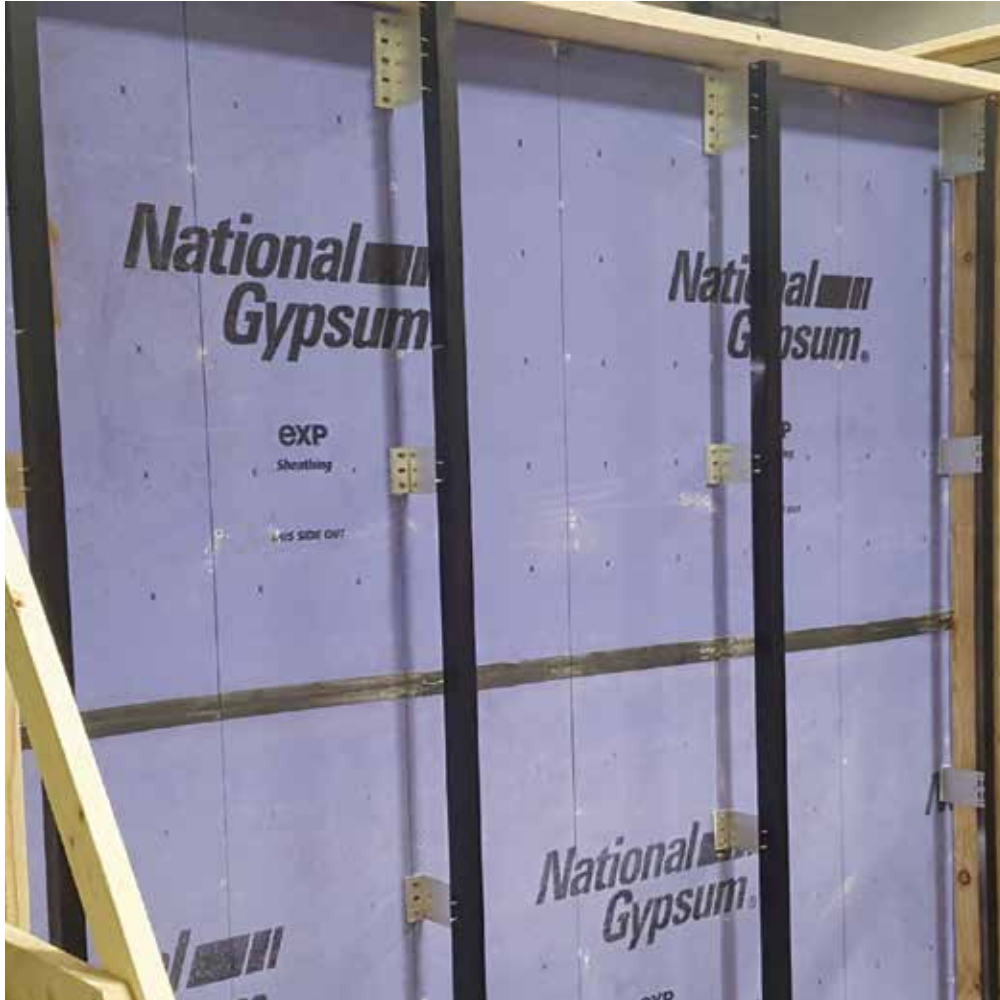
Photo 1

Typical base wall with vertical members installed.

Aluminum angle clips, measuring 1" x 3" x 1¹/₈" thick, 3¹/₄" long, were secured to the base wall using two #12 x 1" stainless steel hex head screws per clip. The clips were spaced 32" on center horizontally and 32" on center vertically. Full-length, vertical aluminum angles, measuring 1" x 2" x 1¹/₈" thick, were secured to the aluminum clips using two #12 x 1" stainless steel, self-drilling hex head screws per clip. Painted steel Tru-Brix trays were secured to the vertical aluminum angles using #8-18 x 3/4" T-2 Lath, 410 SS screws. One screw was utilized at each vertical angle location. Each brick tray was stacked on the tray below.

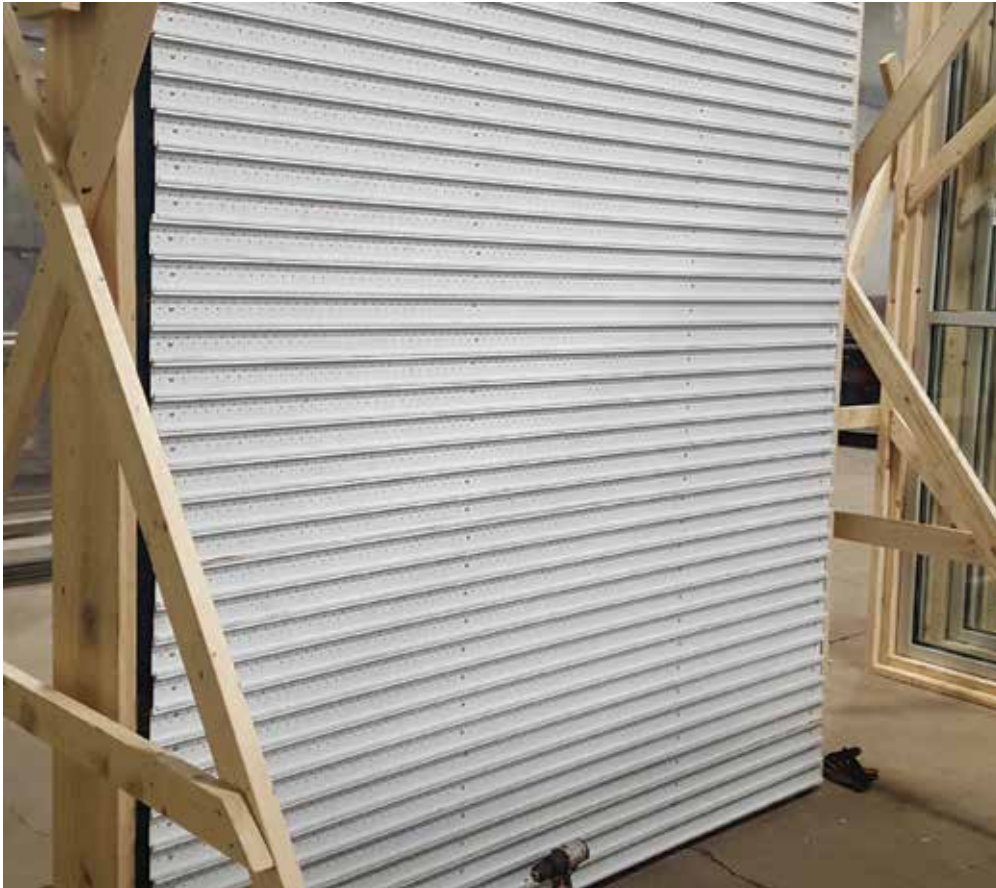
Photo 2

Typical Test Specimen with steel trays installed.

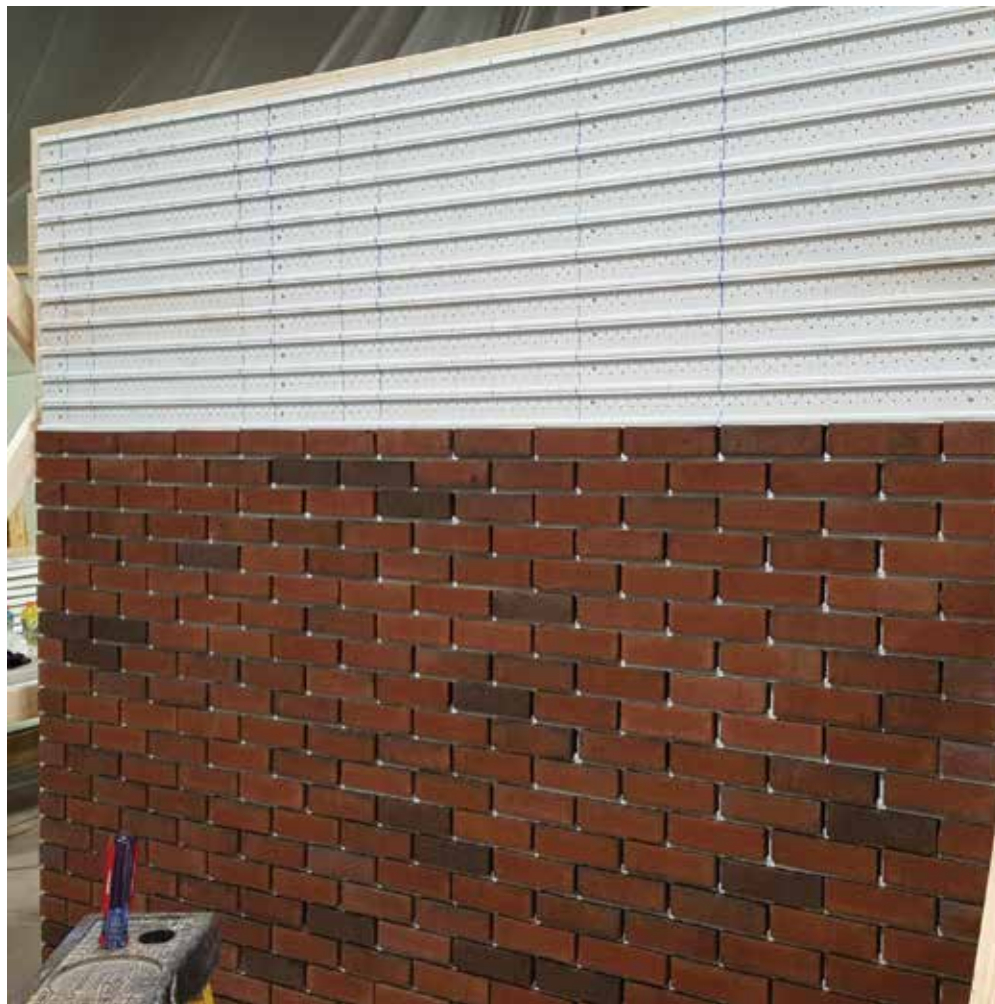
Photo 3

Typical Test specimen with bricks partially installed.

The Tru-Brix anchored bricks were snap-fit into the steel trays, with an approximate 3/8" wide joint between bricks. The mortar joints were manually pointed with Tru-Brix mortar.

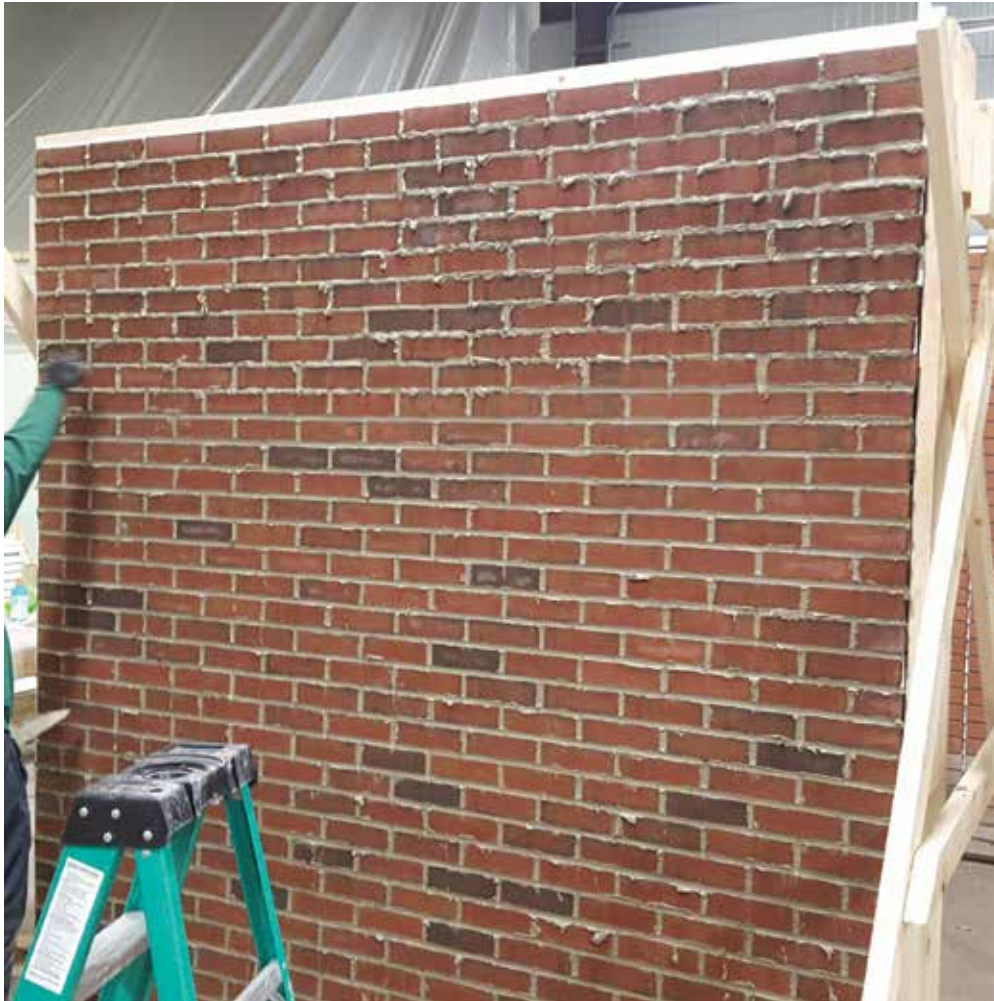
Photo 4

Typical Test Specimen after mortar application.

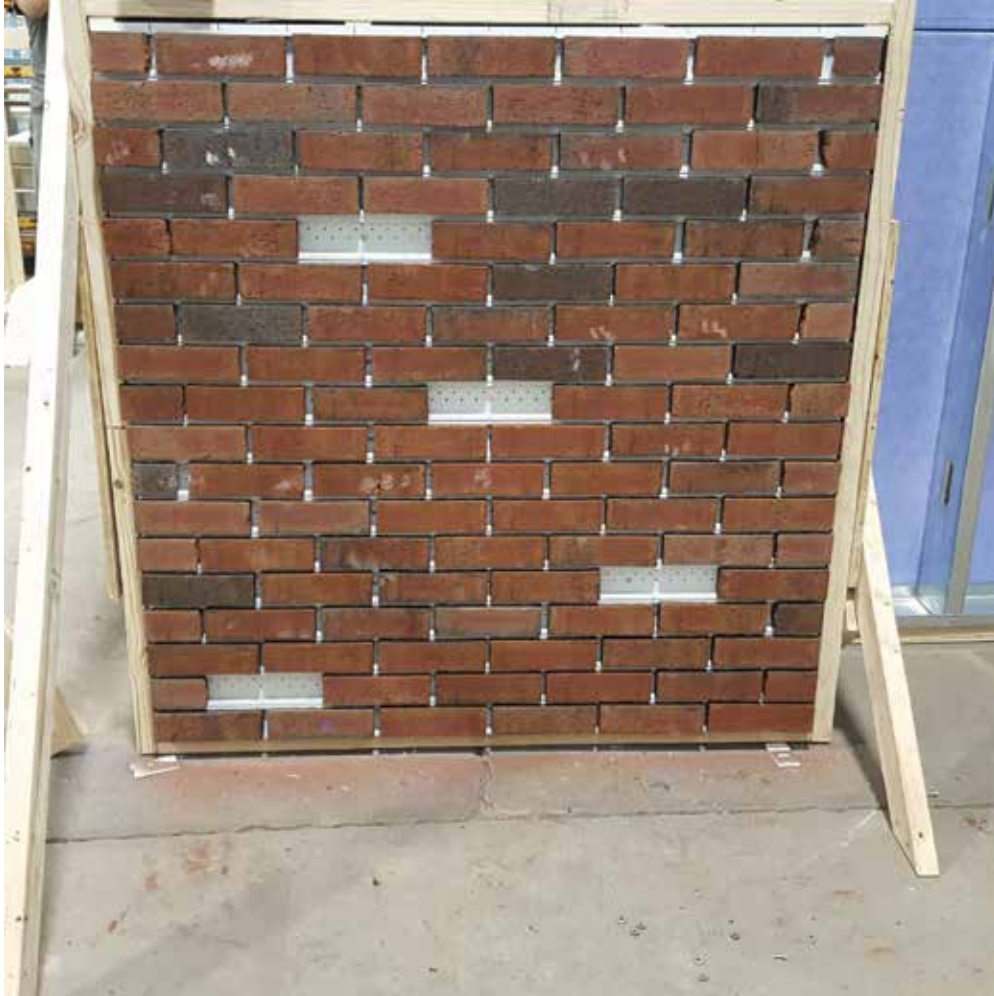
Photo 5

Test Specimen prior to mortar application.

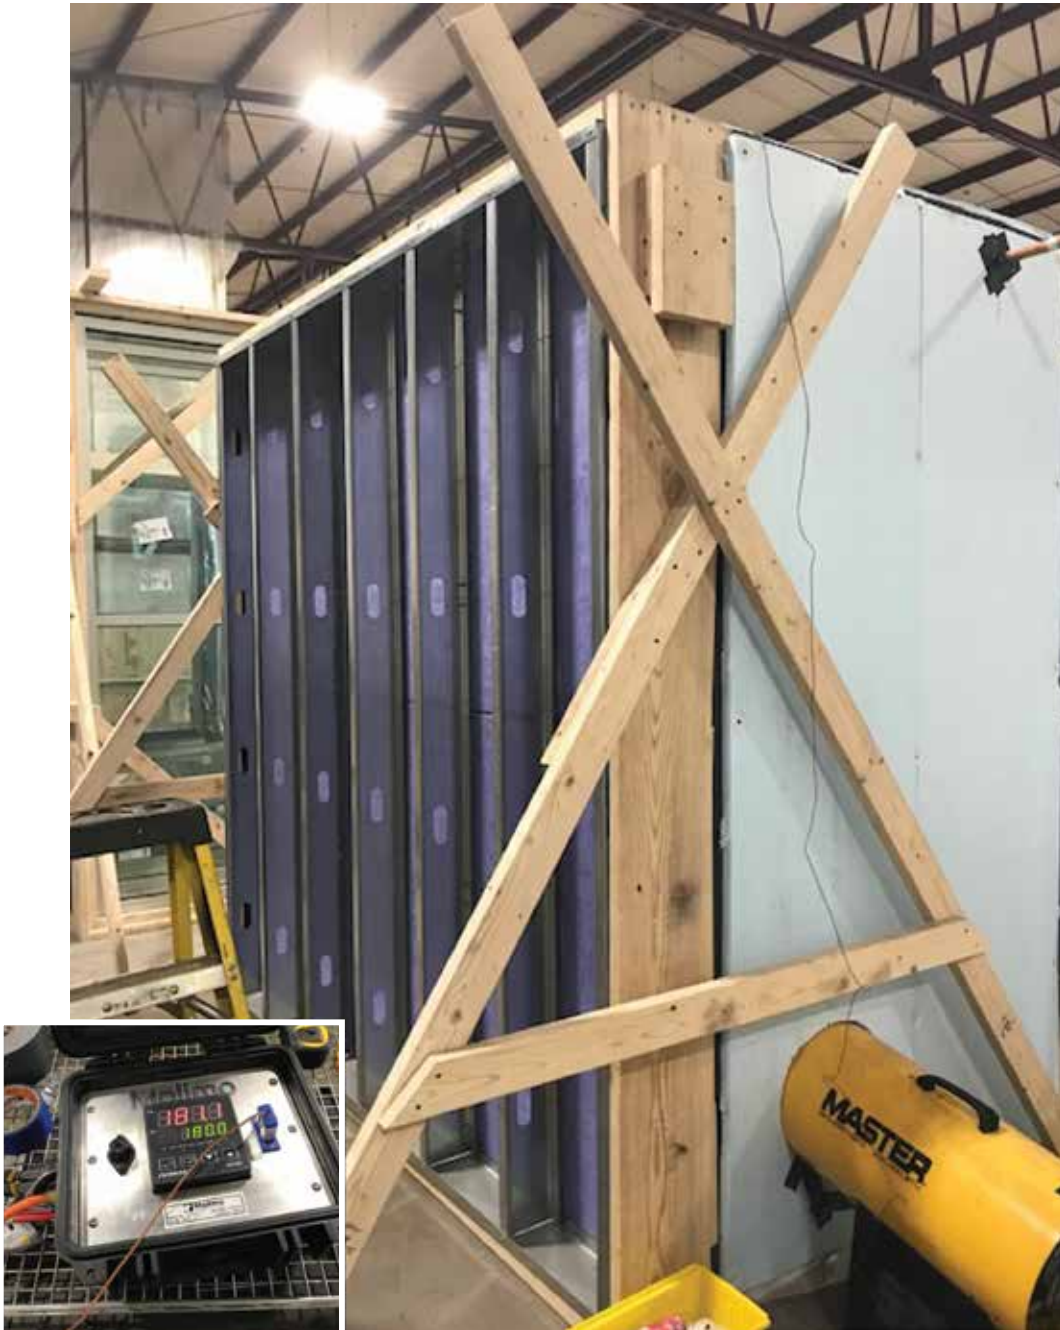
Photo 6

Thermal chamber during the "hot" cycle.

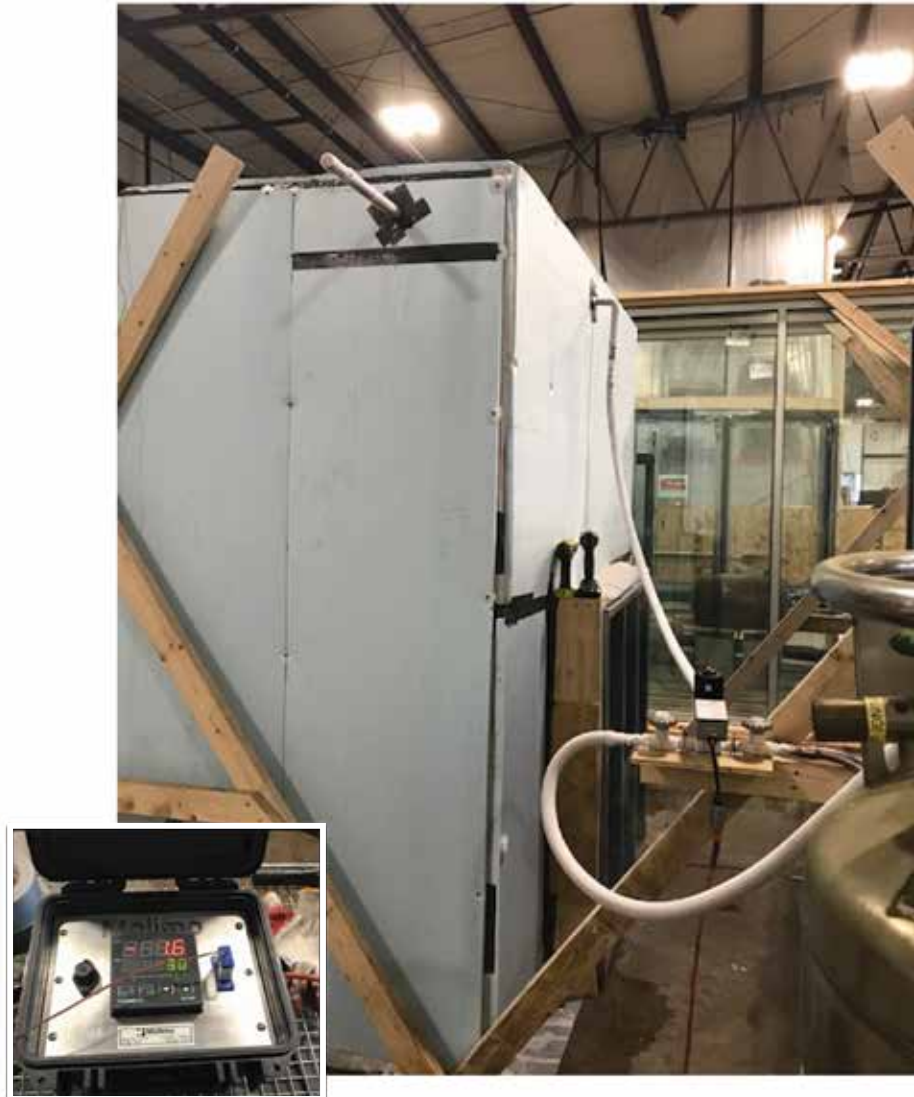
Photo 7

Thermal chamber during the "cold" cycle.

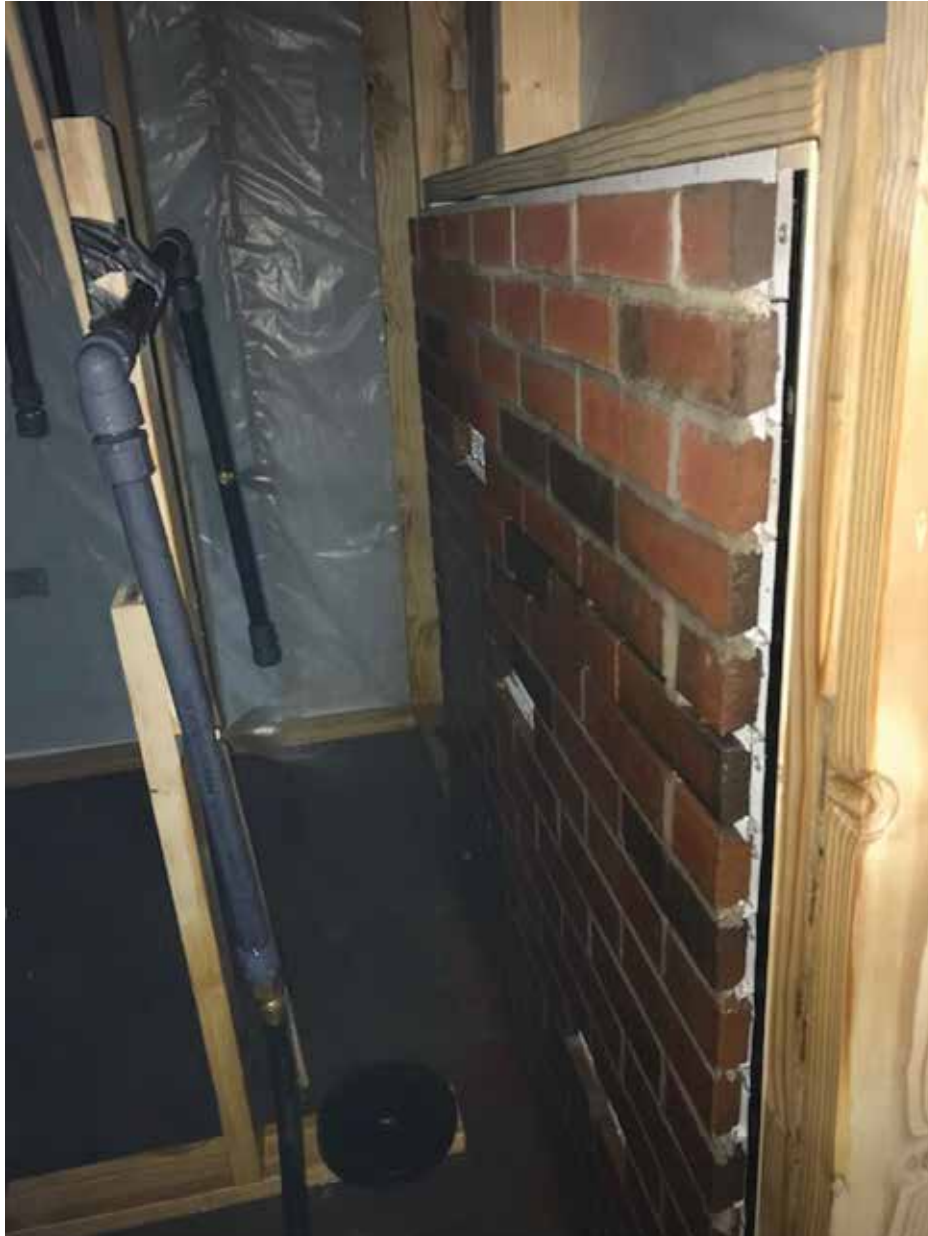
Photo 8

Specimen #2 during water spray of thermal cycling.

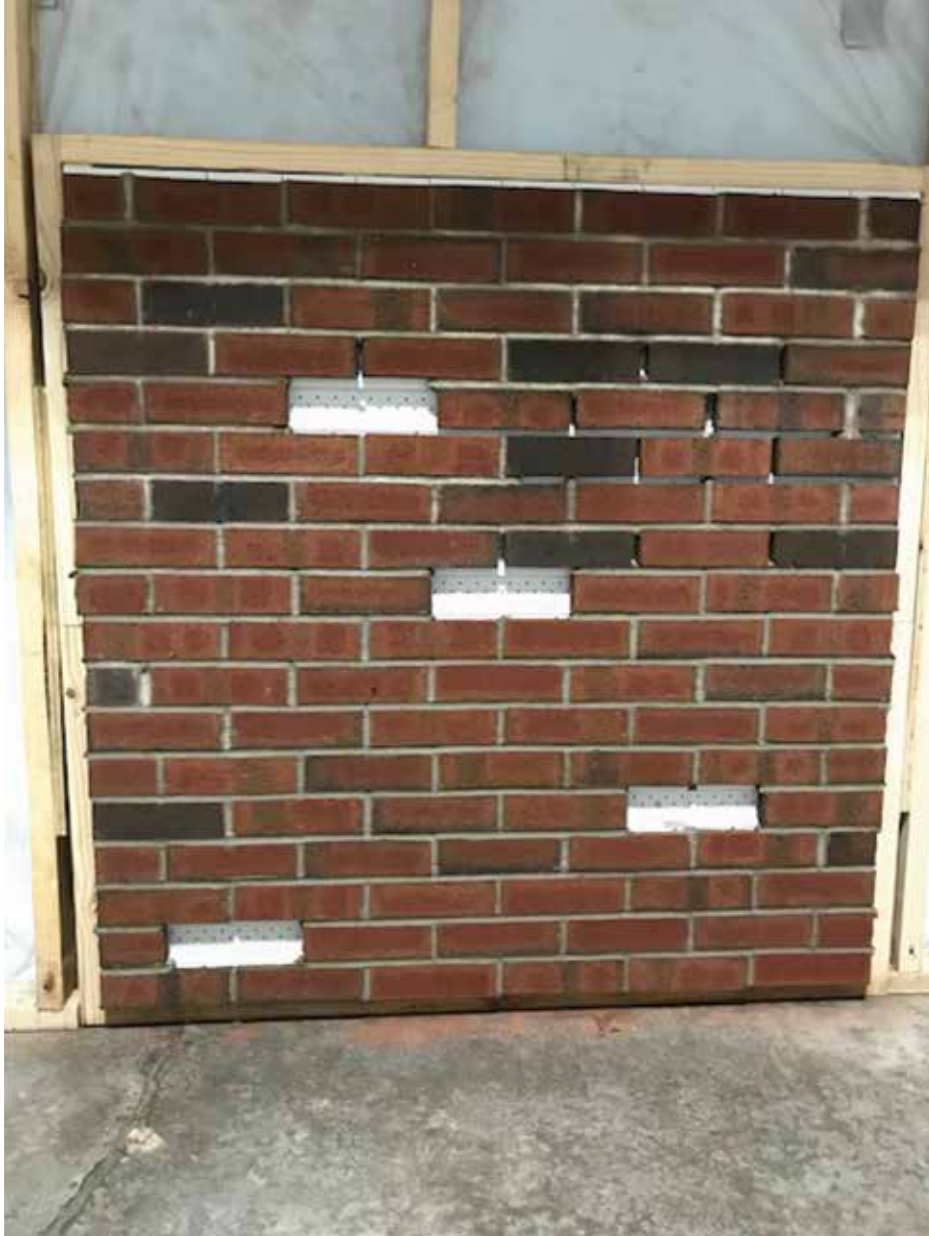
Photo 9

Specimen #2 after 3 thermal cycles.

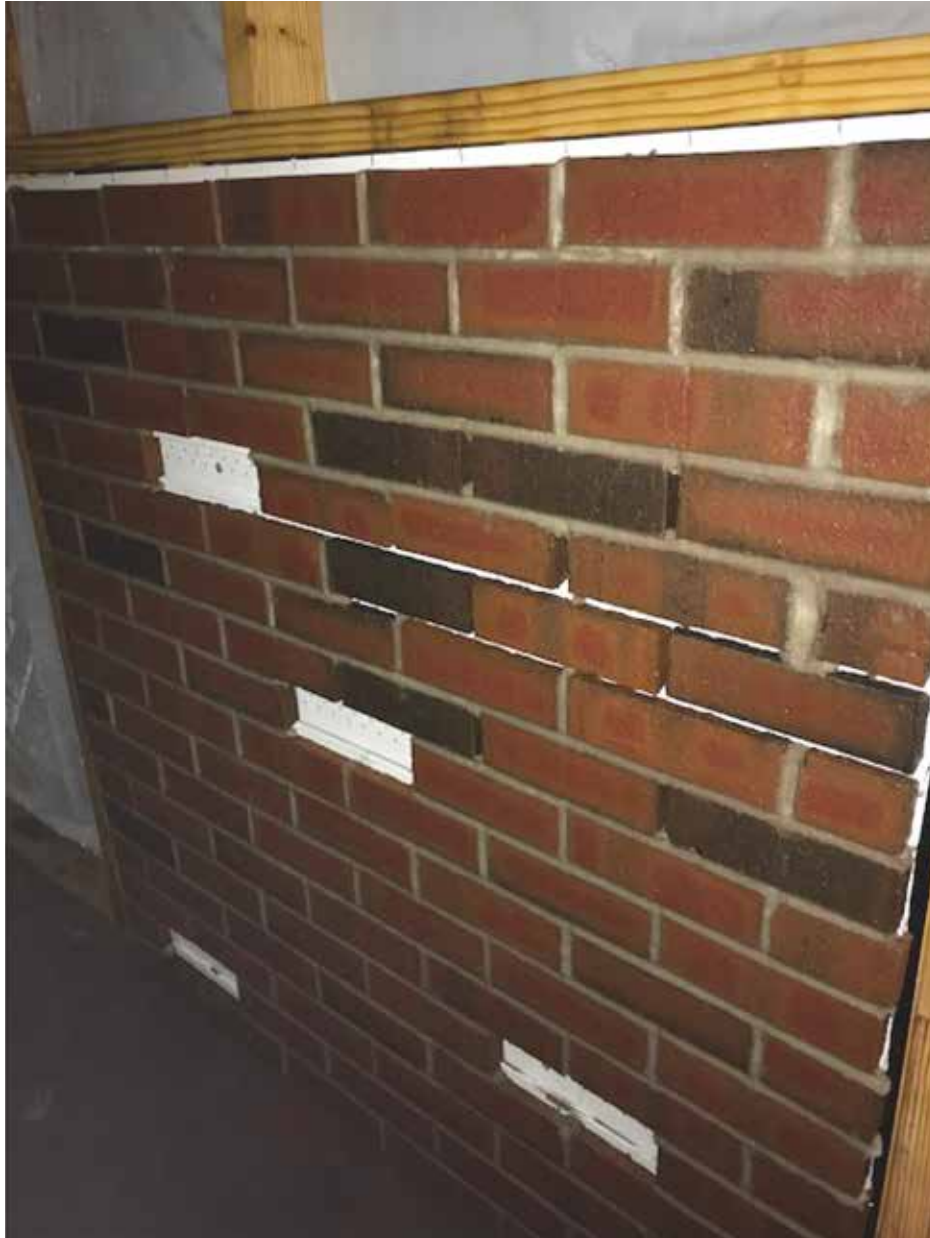
Specimen #2 after 5 thermal cycles.

Several bricks were intentionally omitted during the construction of specimen #2 to allow the water spray during the thermal cycling to get between the bricks and steel trays. The mortar joints in several locations were also omitted. Reference Photo 10 for details on which bricks and mortar joints were omitted from the specimen during construction.

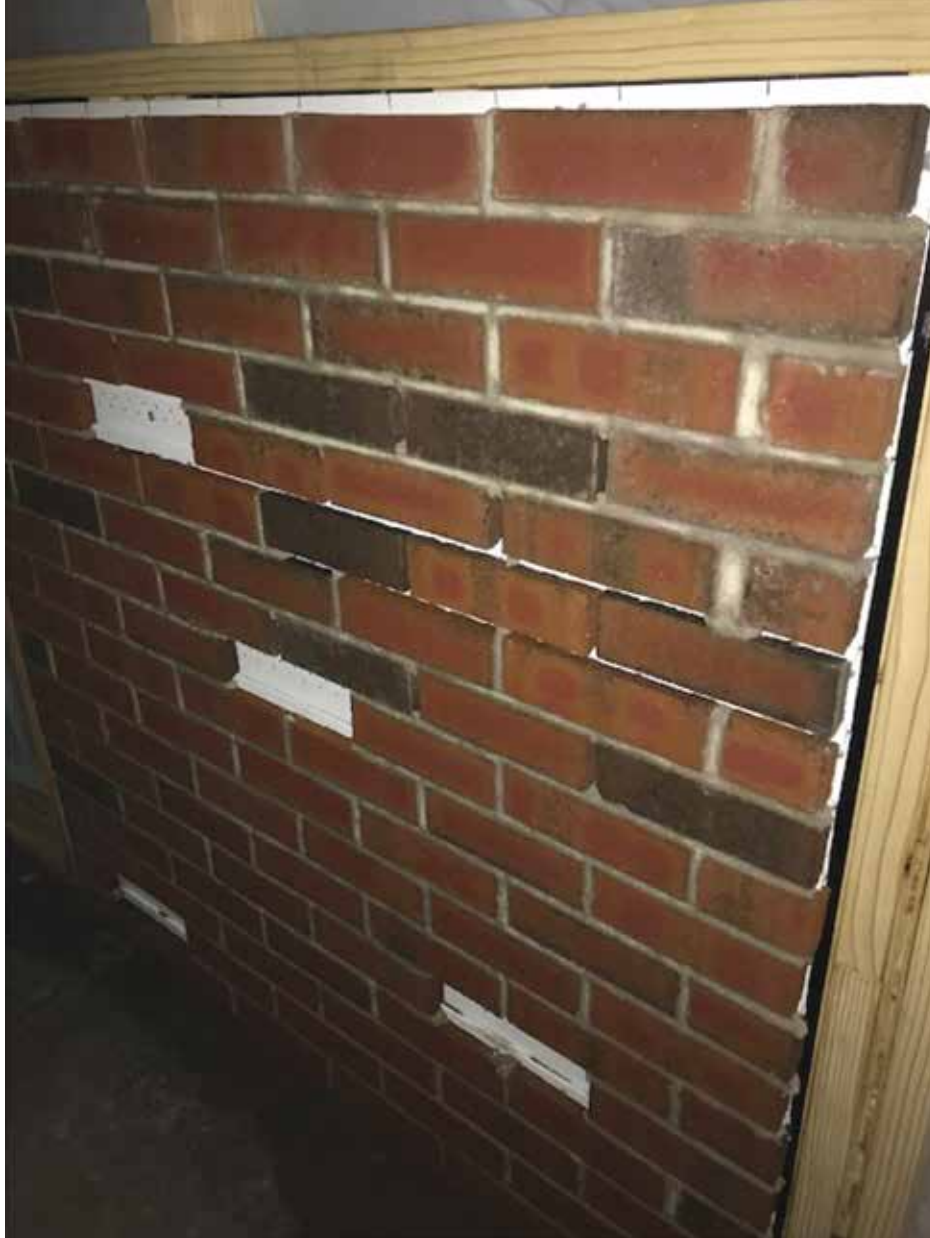
Photo 11

Specimen #2 after 6 thermal cycles.

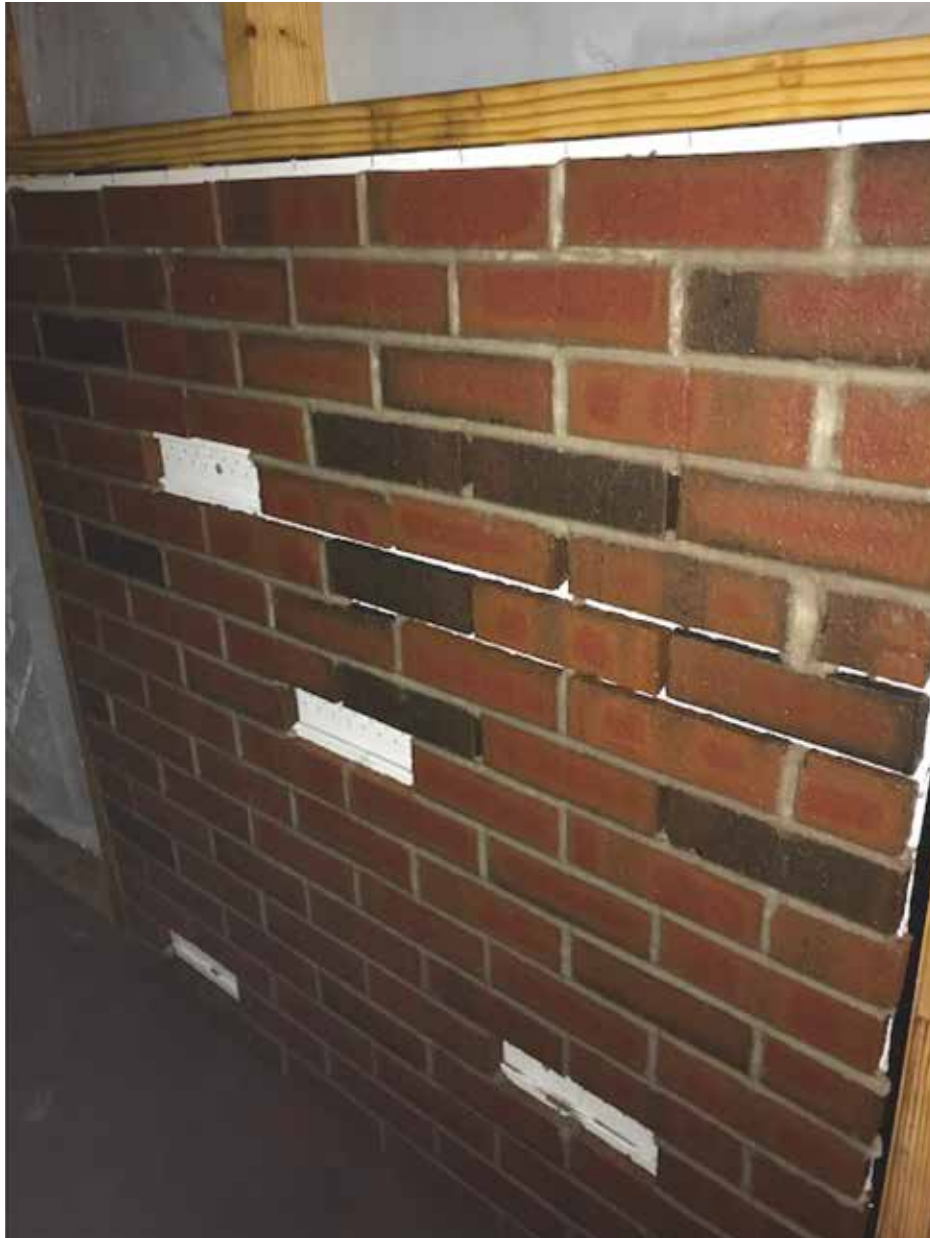
Photo 12

Specimen #2 after 7 thermal cycles.

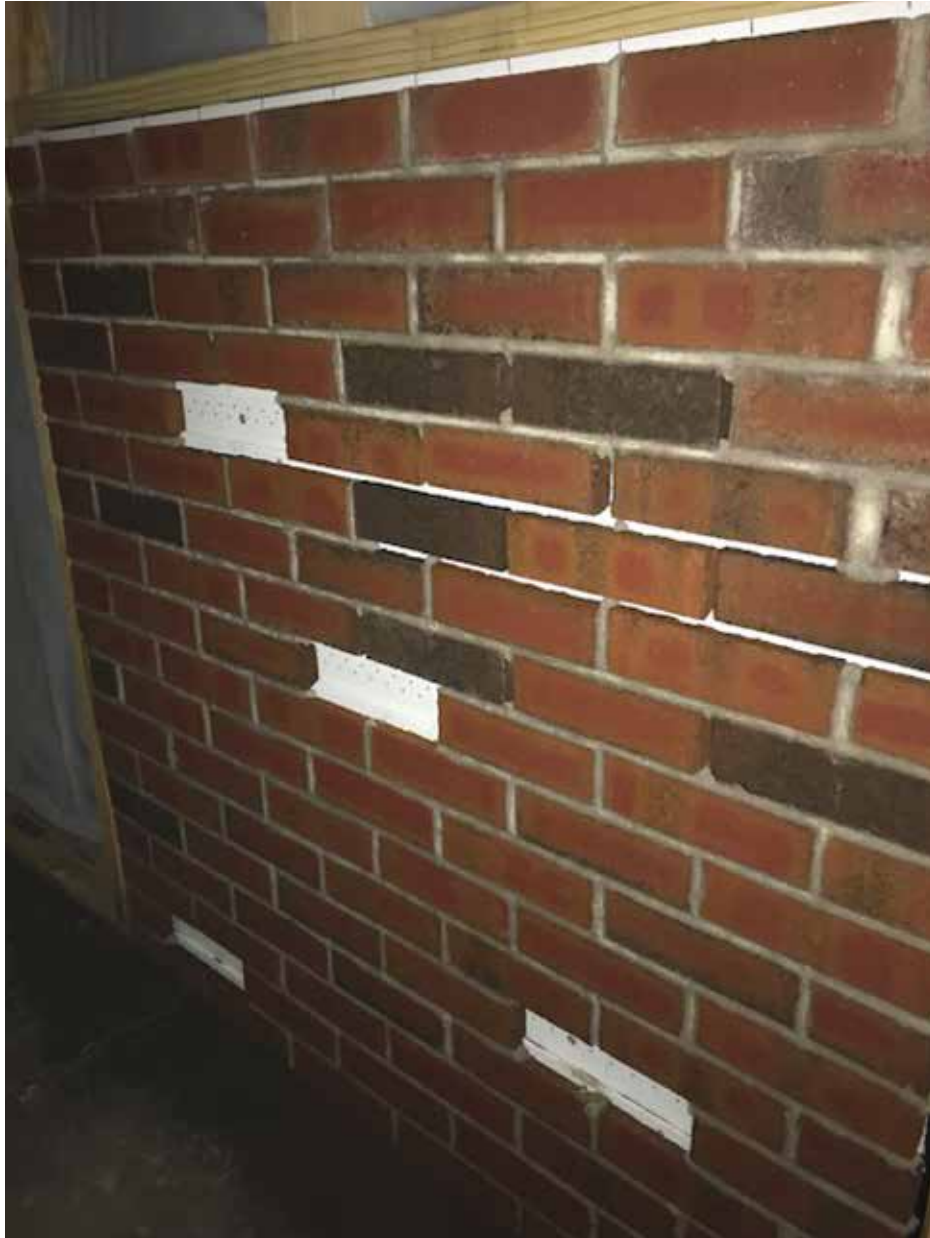
Photo 13

Specimen #2 after 8 thermal cycles.

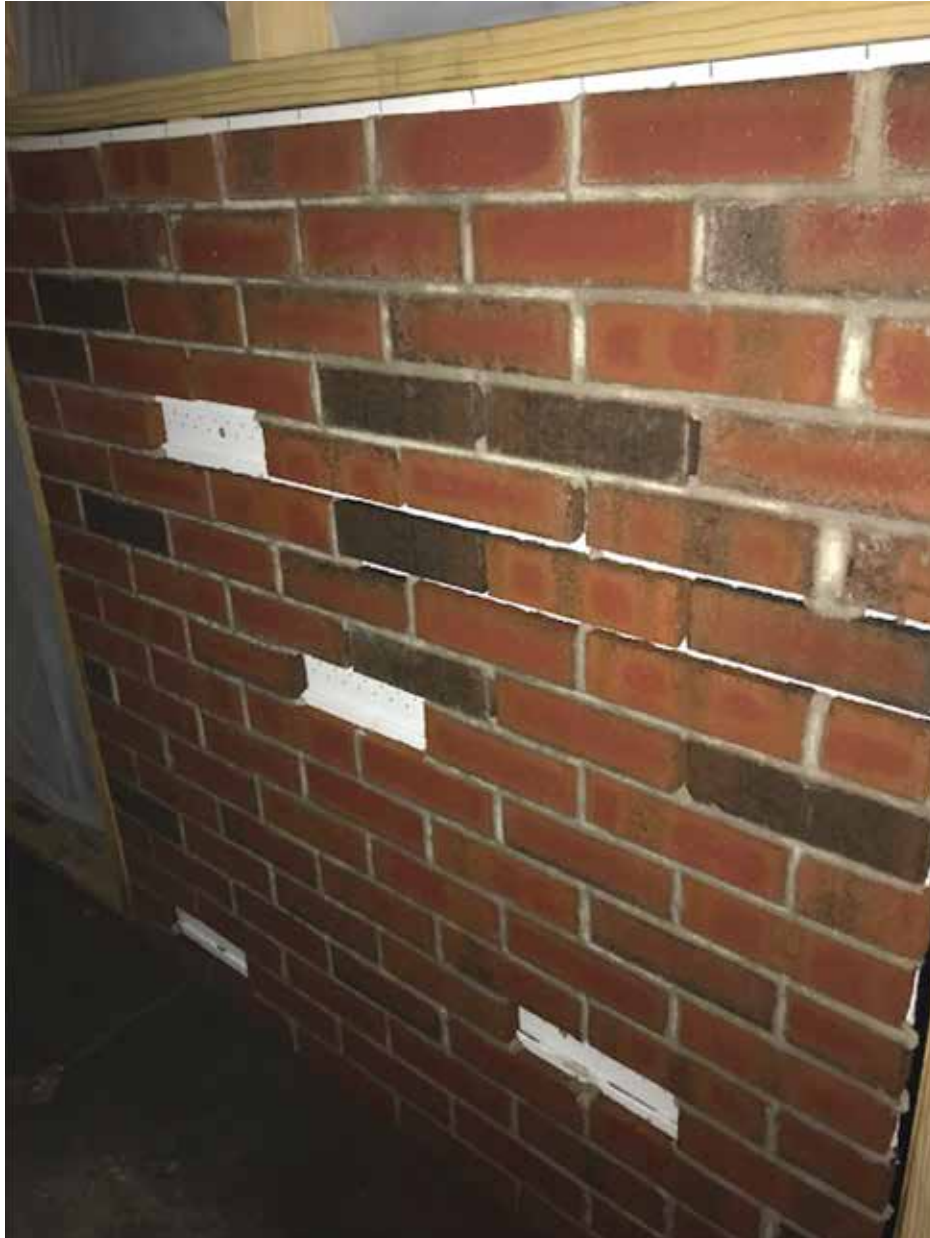
Photo 14

Specimen #2 after 9 thermal cycles.

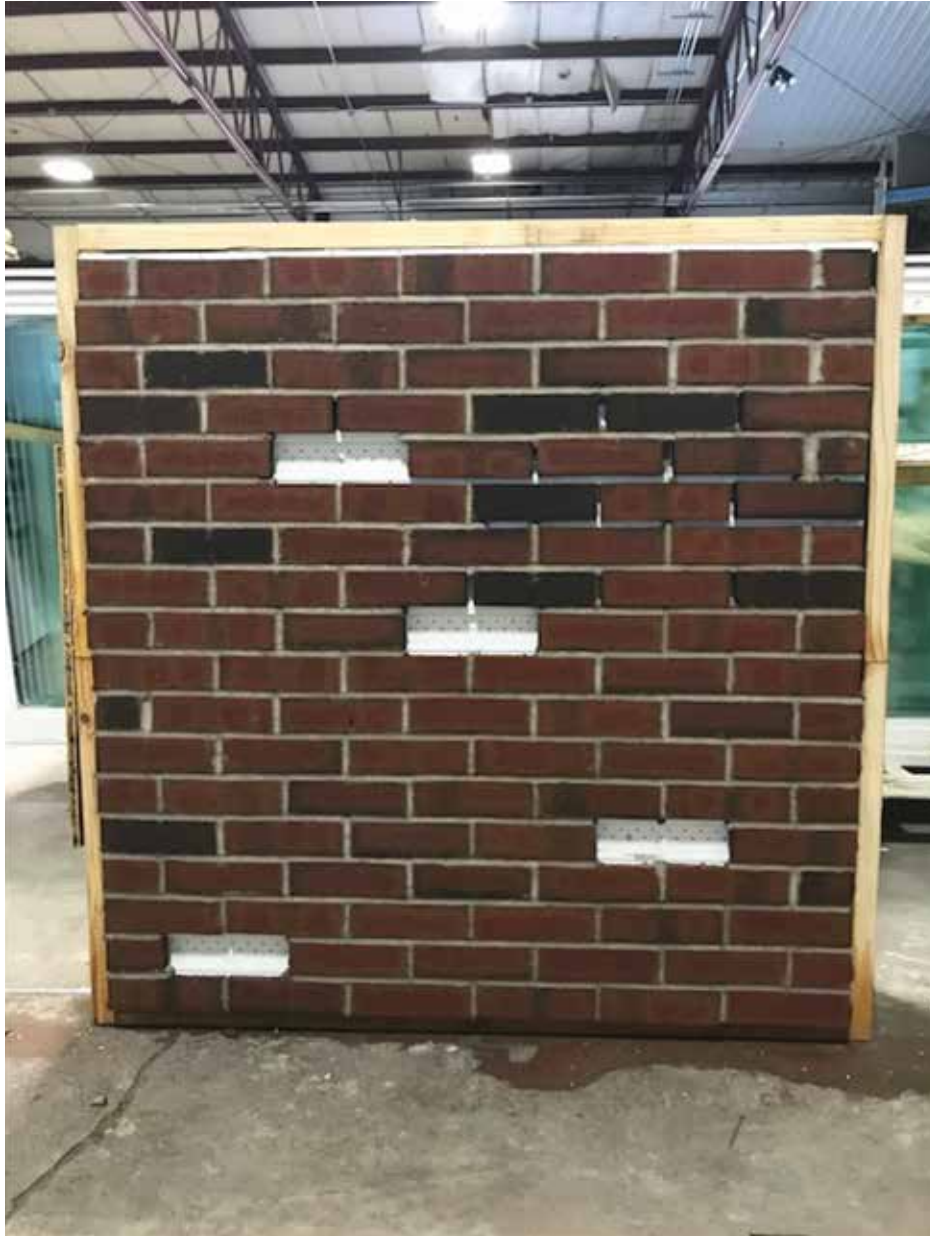
Photo 15

At the completion of the thermal cycle test, the specimen was visually inspected. There were no signs of bricks loosening or becoming dislodged from the specimen. Over the duration of the testing, the bricks experienced some slight decolorization.

Specimen #2 after 10 thermal cycles .

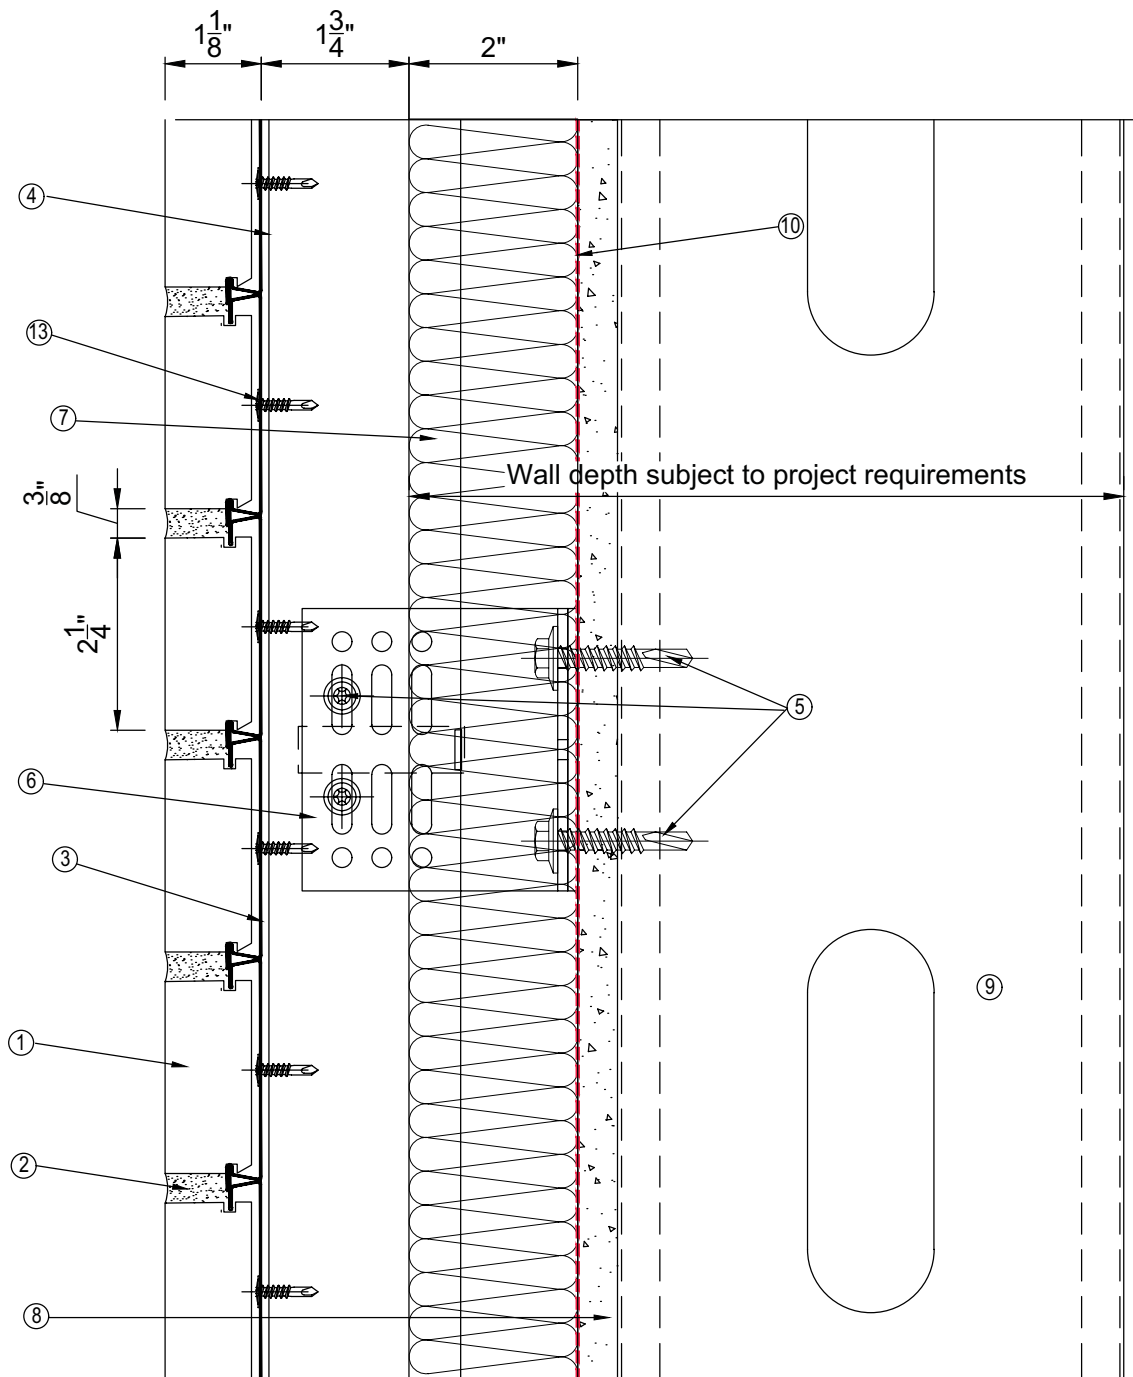
Size	Drawing No.	Rev.
A3	DET-001	/

Drawing Title :
Vertical section detail through
brick on metal frame

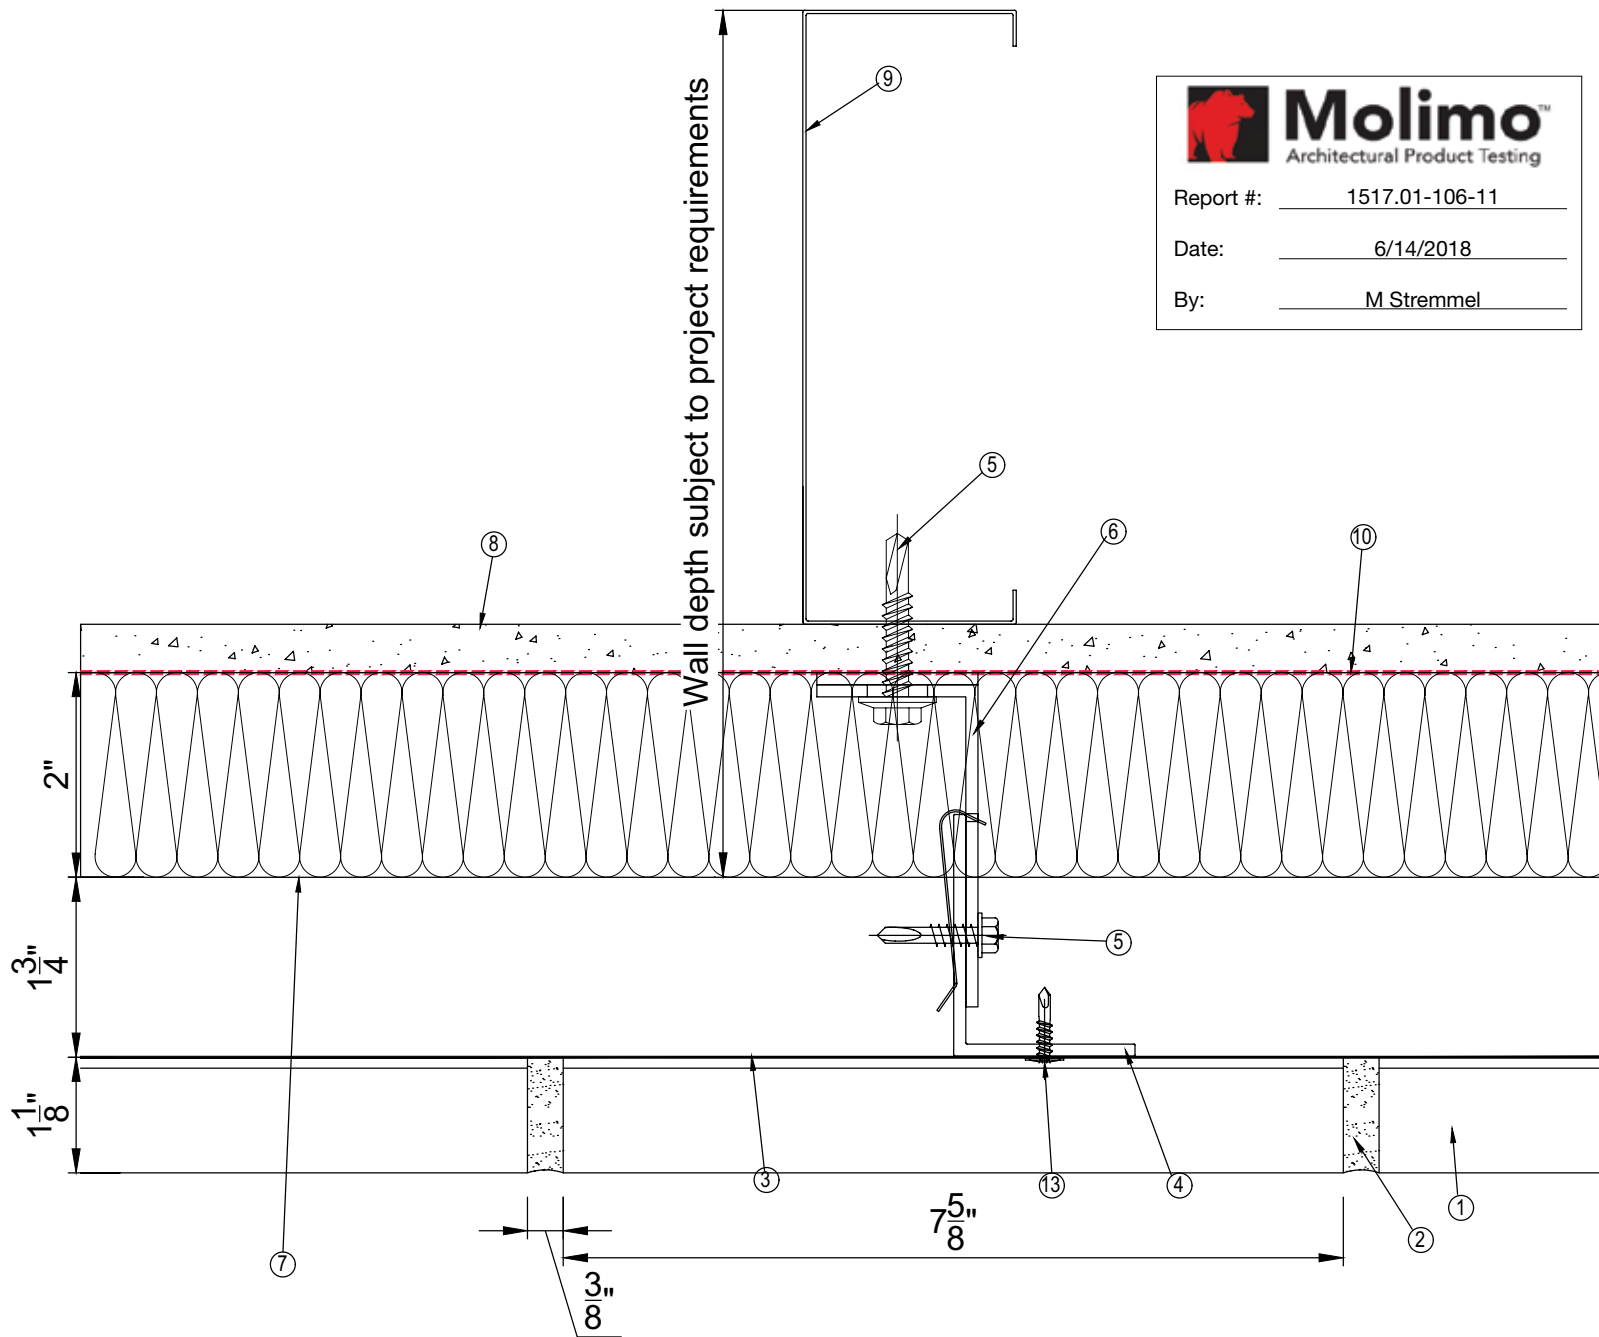
A3 DET-002 /

Drawing Title :
Horizontal section detail
through brick on metal frame
