TEST REPORT

AAMA 501.5

REPORT NO.: 1517.02-106-11-R0

SERIES / MODEL: Tru-Brix Rainscreen System

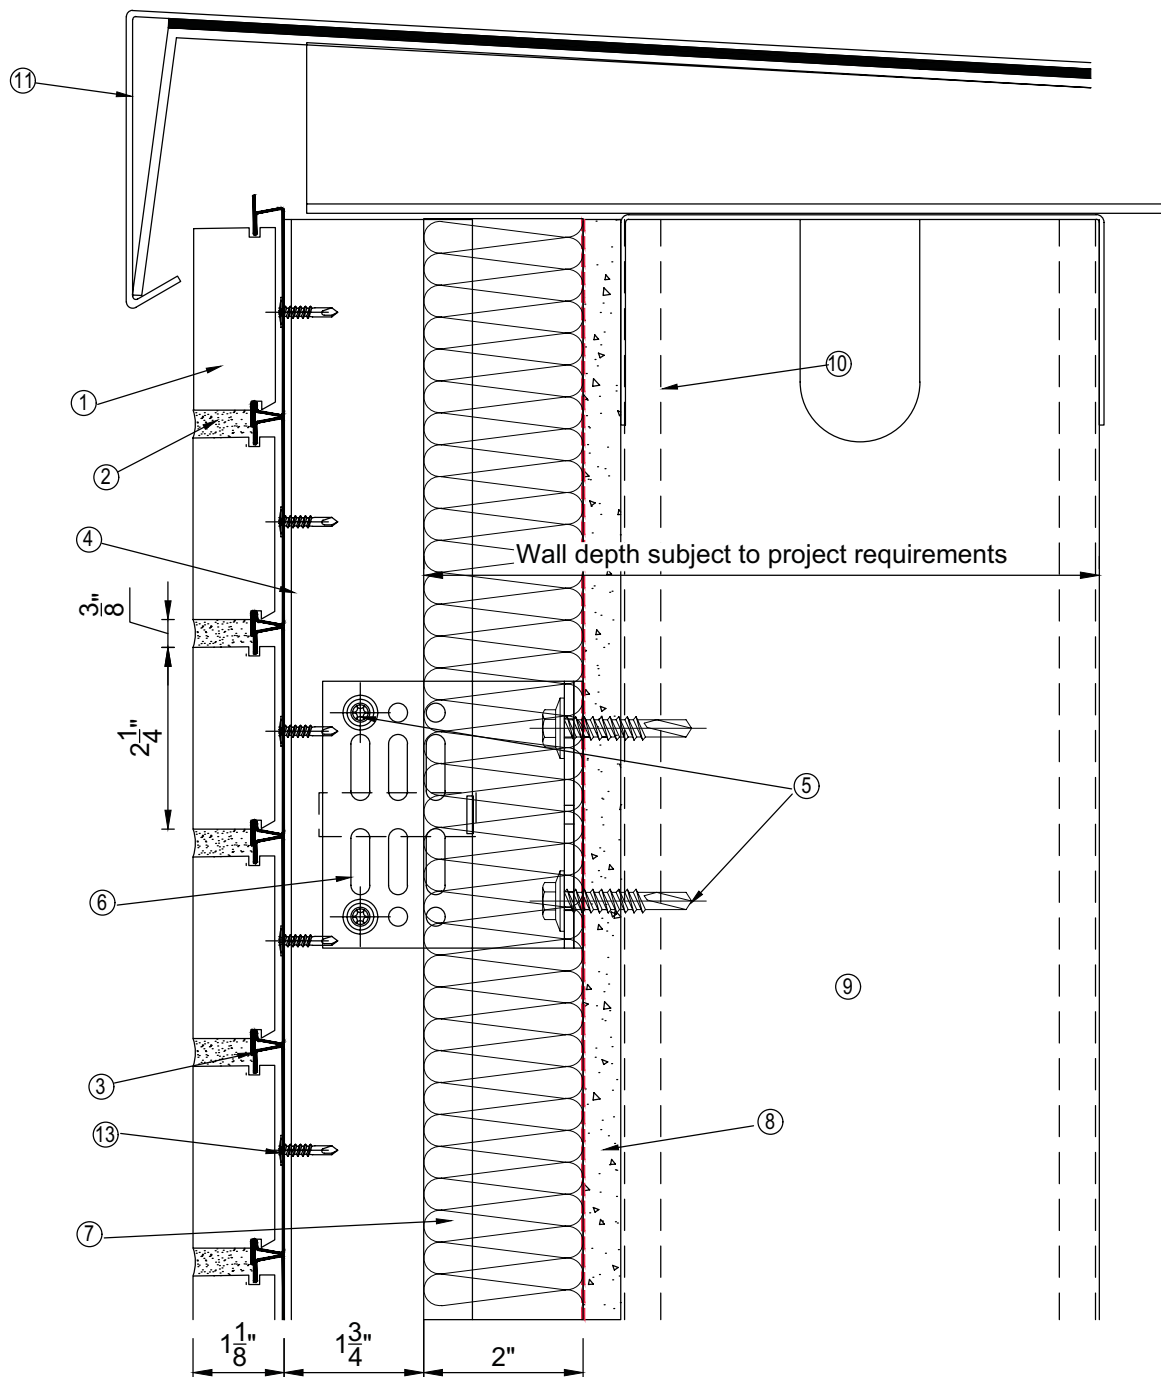
A3 DET-003 /

Drawing Title :
Vertical section detail through
brick on metal frame to capping

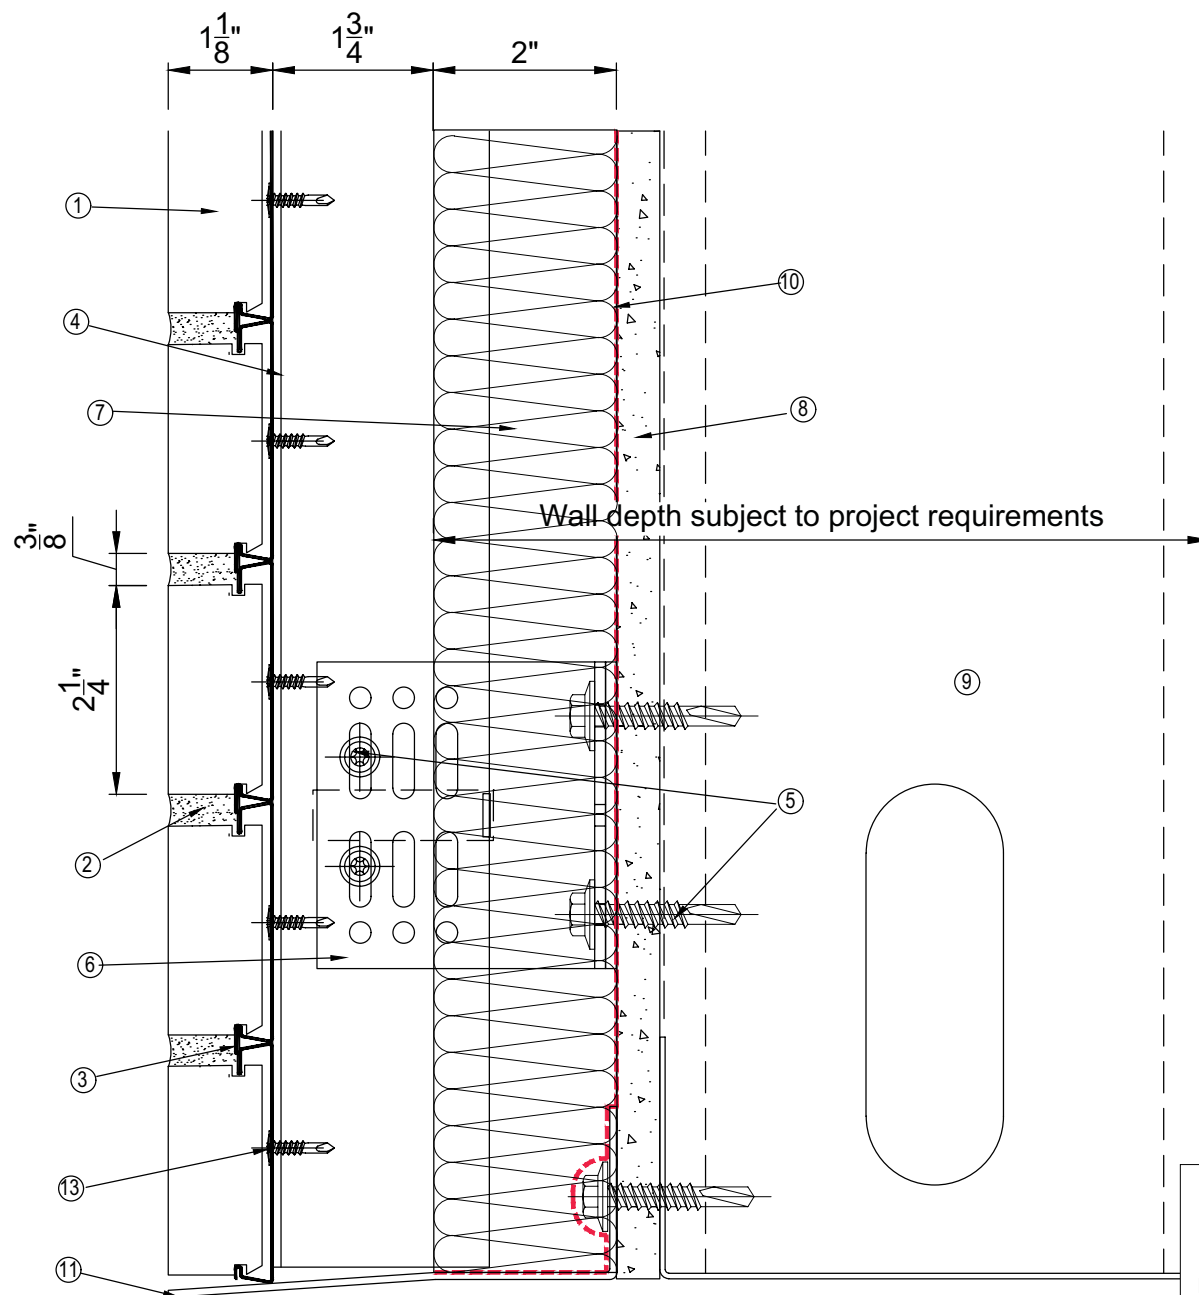
A3 DET-004 /

Drawing Title :
Vertical section detail through
base of brick on metal frame

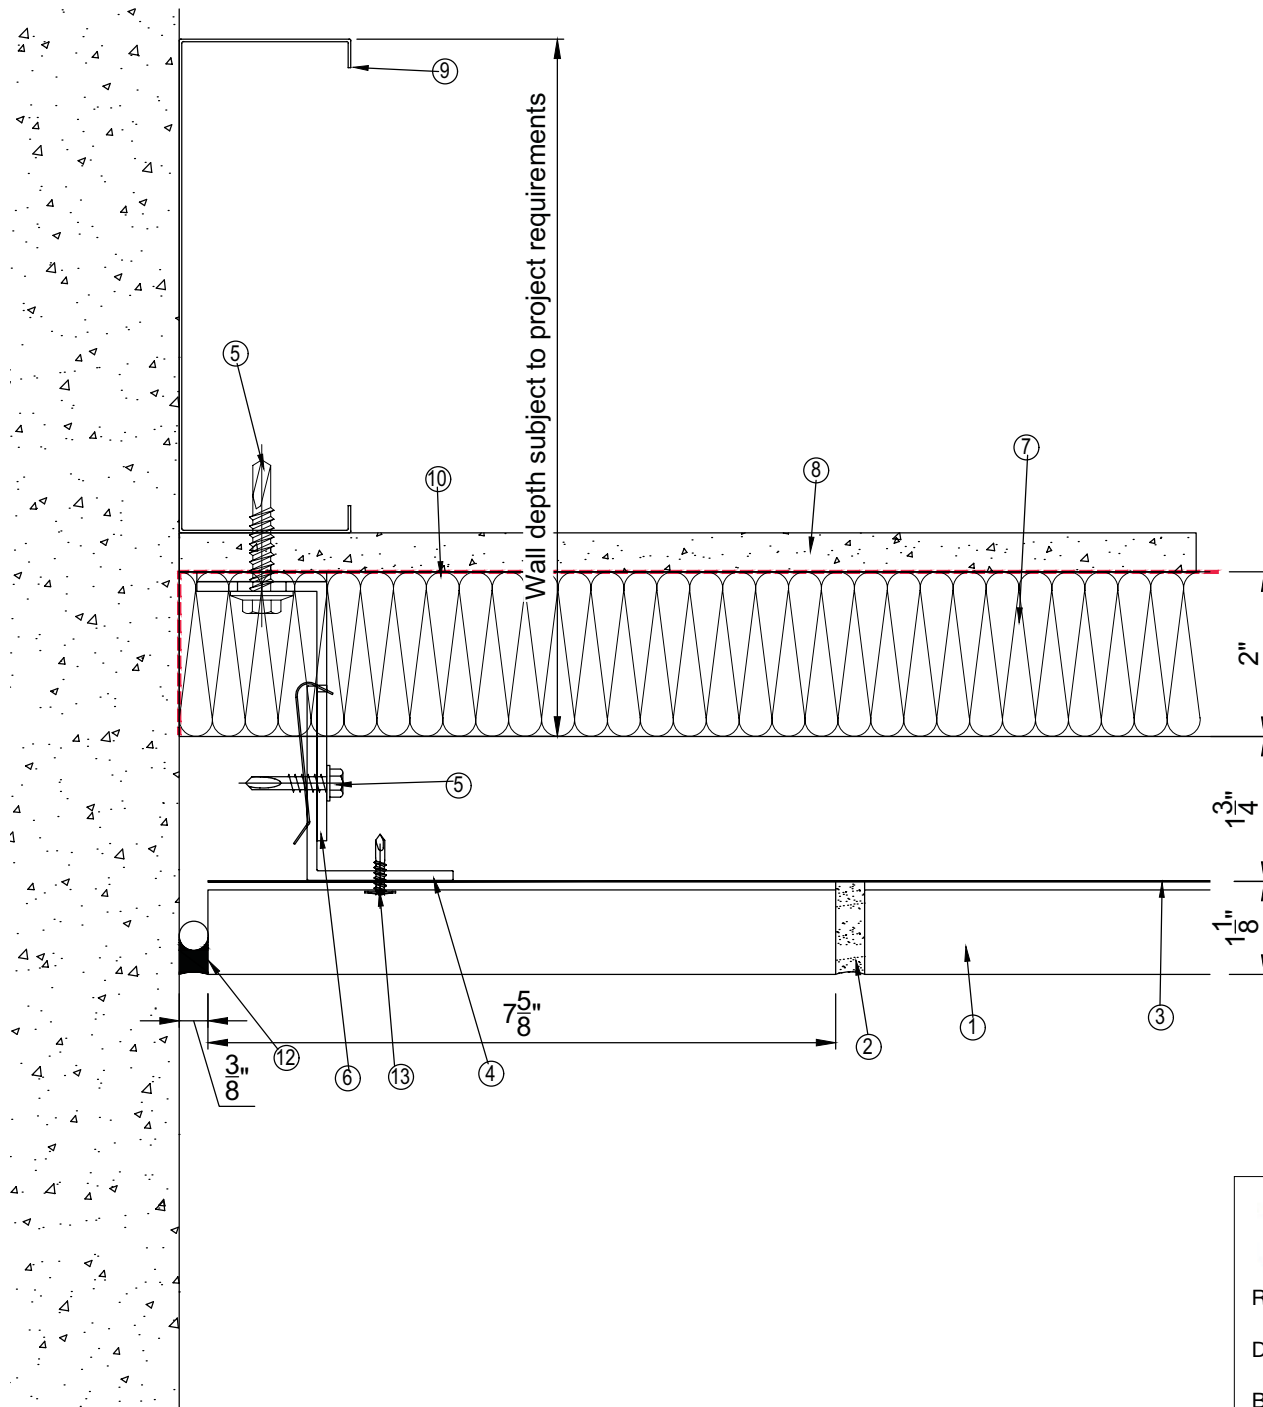
Size	Drawing No.	Rev.
A3	DET-010	/

Drawing Title :
Horizontal section detail
through brick abutment

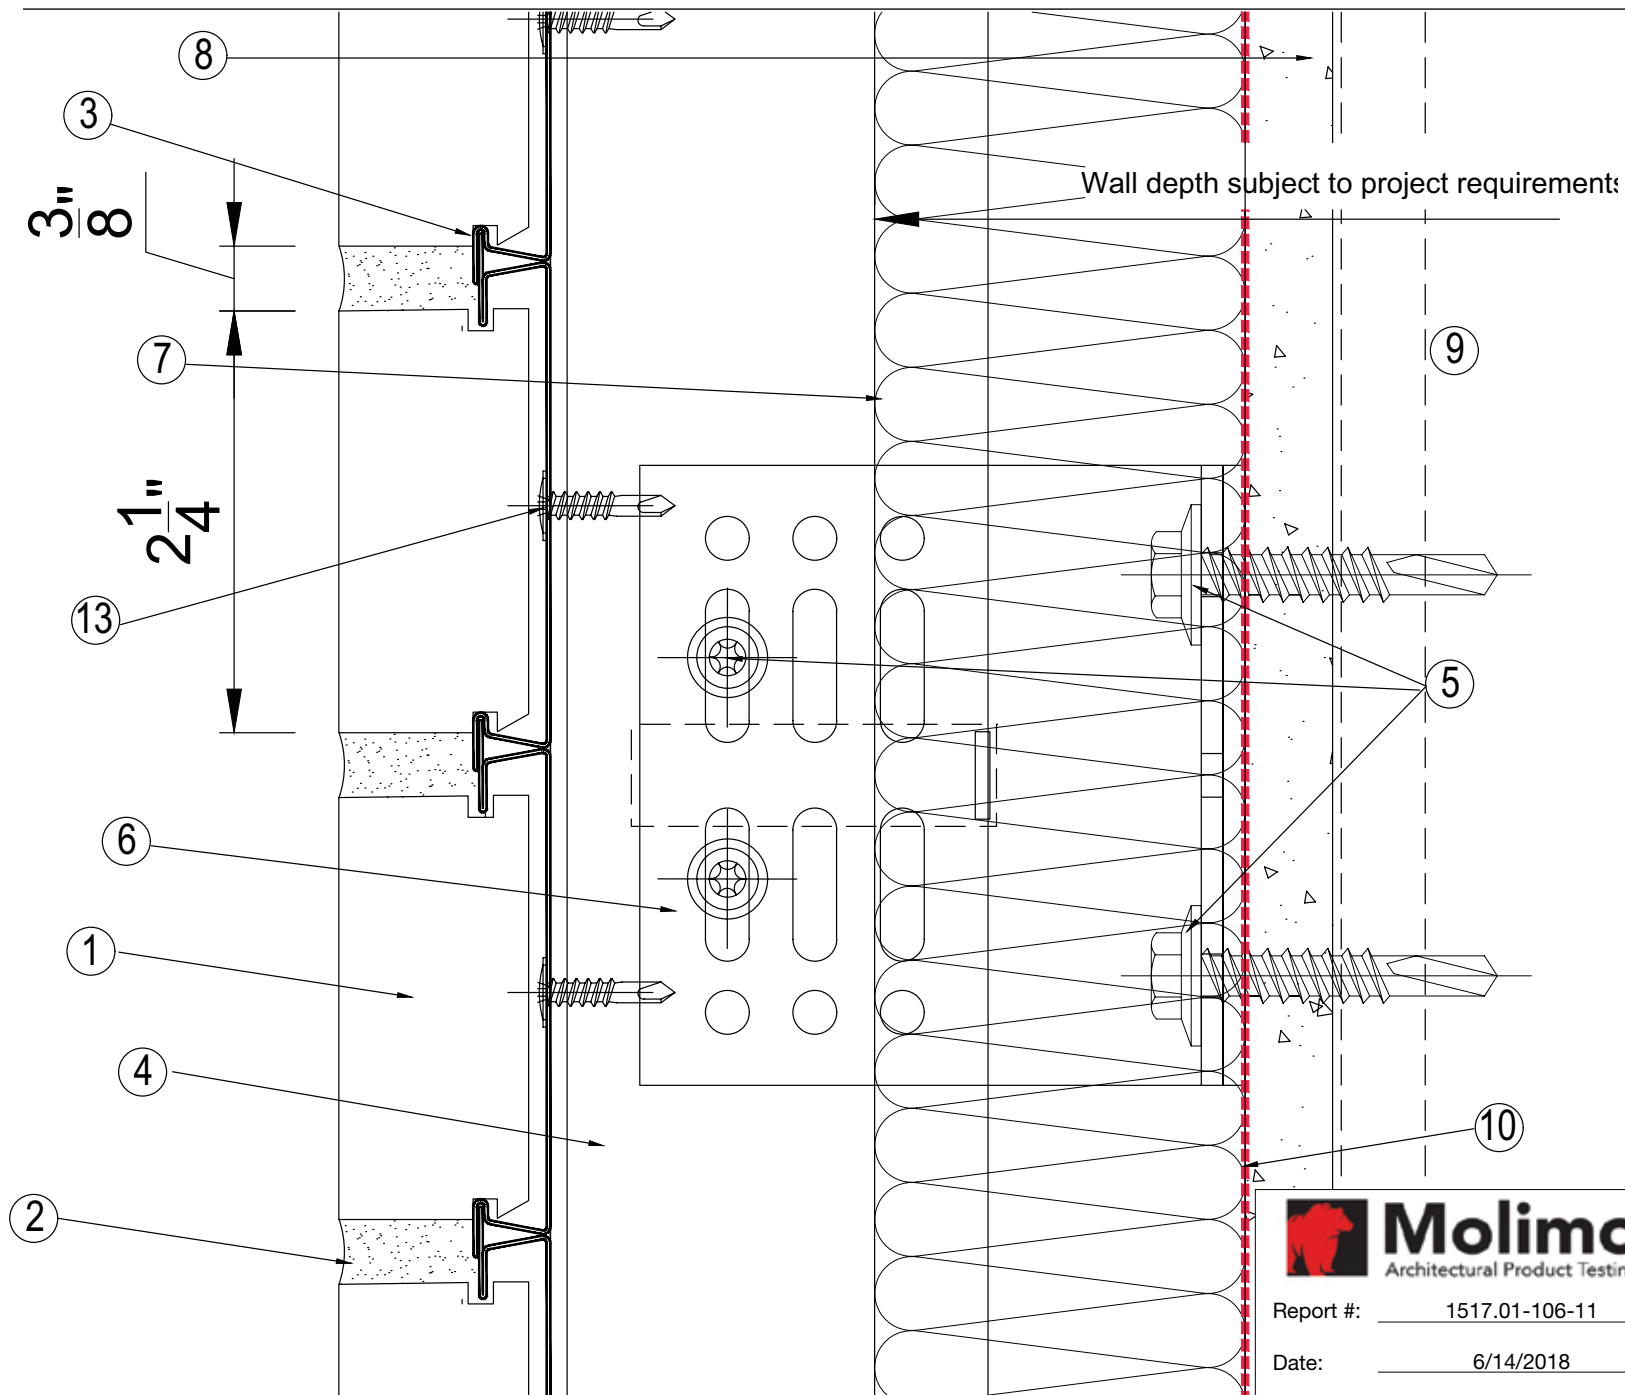
Drawing Title :
Enlarged Vertical section detail
through brick on metal frame
